Manhole Inspection Summary

Manhole # S45K__033MH

Location Address: **side 1810 fleet st**

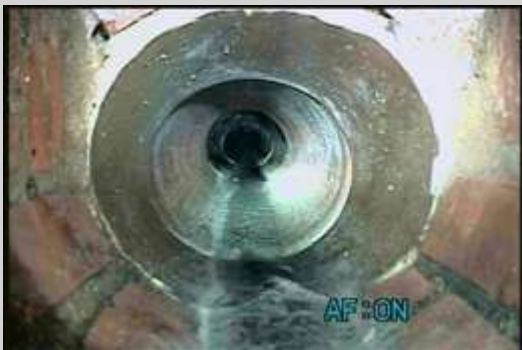
12 O'Clock Outflow

8 in. Circular Gravity Sewer
Pipe Out @ 12 O'Clock

Pipe Material: Clay ☐ Pipe Lined

Invert Depth: 10.90 (ft.) Flow Characteristics: Fast

Infiltration: None Pipe Seal Cond: Unknown

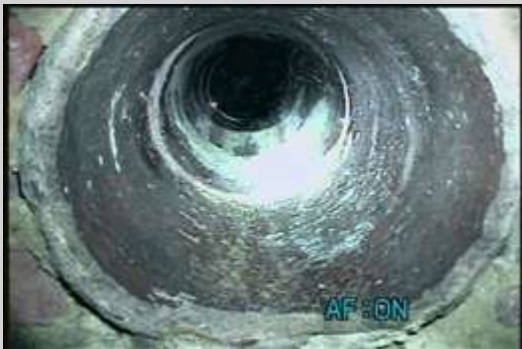
6 O'Clock Inflow

8 in. Circular Gravity Sewer
Pipe In @ 6 O'Clock

Pipe Material: Clay ☐ Pipe Lined

Invert Depth: 8.33 (ft.) Flow Characteristics: Fast

Infiltration: None Pipe Seal Cond: Unknown

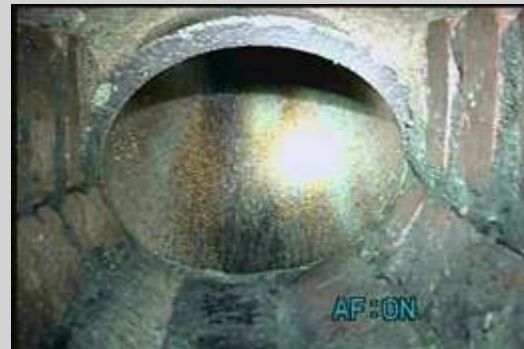
Drop In @ 6 O'Clock

Drop: Outside Direct

Inv Depth: 10.75 (ft.)

Drop Condition: Open

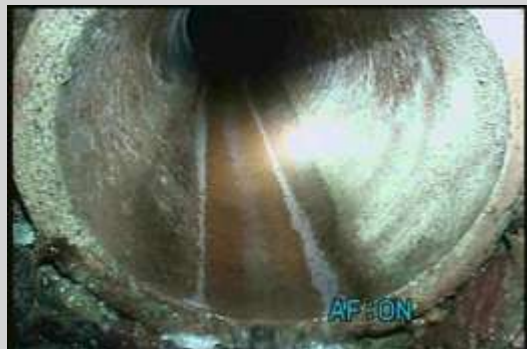
8 O'Clock Inflow

8 in. Circular Gravity Sewer
Pipe In @ 8 O'Clock

Pipe Material: **Clay** ☐ Pipe Lined

Infiltration: **None**
